SAFETY ALERT (SA)

BULLETIN : SA-22-01

SYSTEM : Hydraulic/Electric

AFFECTED TANKS : All Spray King® Tanks with stainless steel hydraulic manifold box installed.

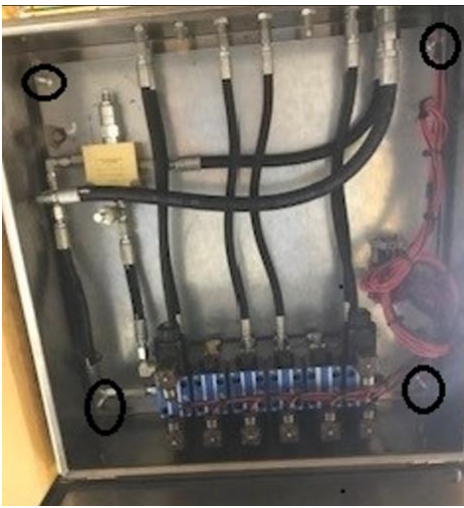
Pic 1

REASON : Back plate unable to hold weight of installed manifold and solenoids when operated in rough terrain.

One time inspection for presence of stainless-steel box. When present, open box and check condition of back plate where the plate is secured by the four nuts (Pic 1) . No damage or should be present

Contact cornelis.hagen@holtmfg.com and raul.cuevas@holtmfg.com with tank serial number and findings.

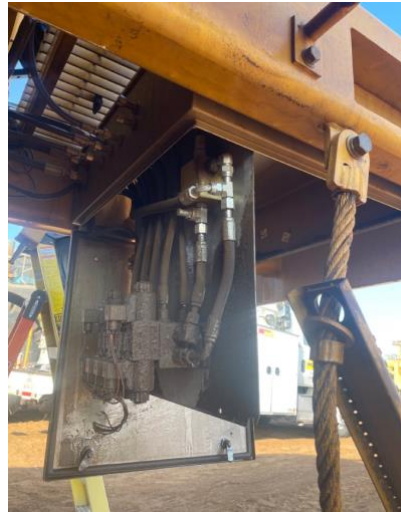
Pic 2

When back plate, studs, or nuts did fail, manifold assembly can fall from opened box (Pic 2). Keep the area clear and always wear appropriate Personal Protective Equipment (PPE), including eye protection, gloves, and long sleeves to prevent cuts due to sharp edges and objects.
